Two Year Saltwater Immersion Simulation Testing

To prove the effectiveness of the RG (reactive gel) family of products, we tested it in a 5% salt solution. To make the test more severe, we introduced oxygen to the water through aeration tubes. Also we used the most porous type of insulation, which is fiberglass.

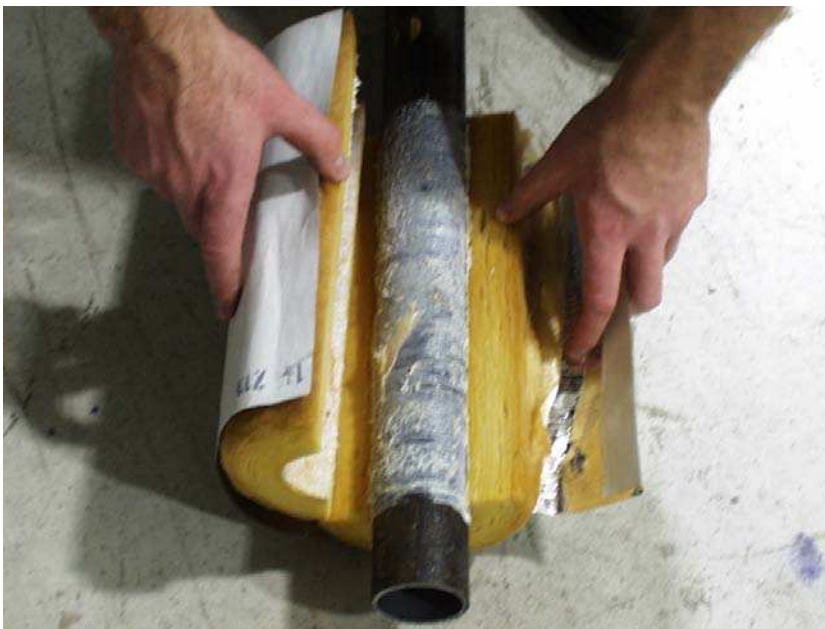
Both bead blasted pipe and mill scale as received were used in the test. A close up of bead blasted pipe is above.

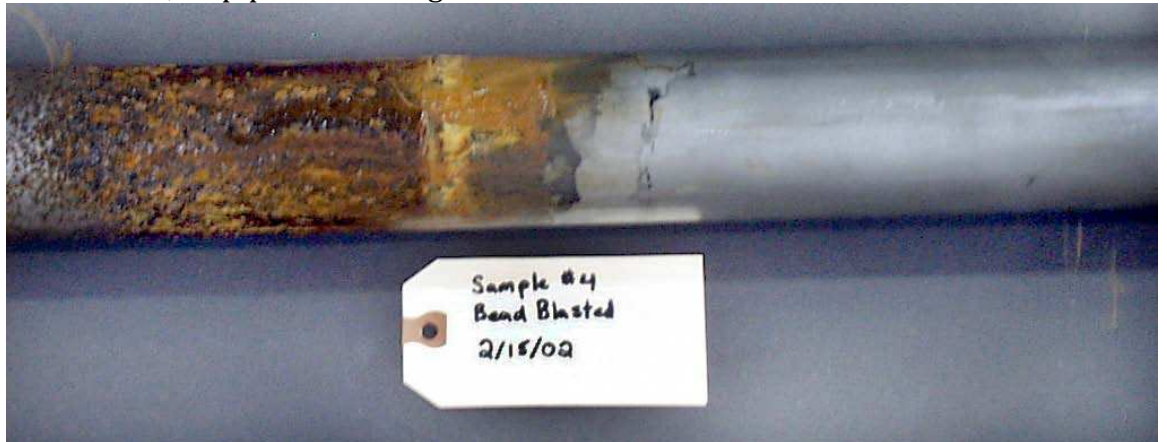
At 31 Days

At 31 days, a pipe was removed and cleaned. A difference in corrosion is already apparent. Note the transition area above the tag; at this area the insulation cover slipped down a couple of inches during the test. When this was discovered, all pipes remaining in the saltwater bath had the insulation secured and

the test proceeded.

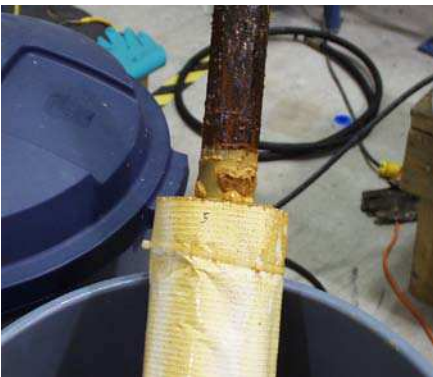
At 81 Days

At 81 days, this sample was removed. This pipe was one of those with mill scale as received. It had no corrosion on the treated area.

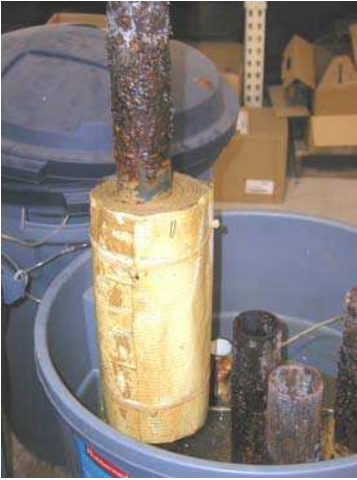
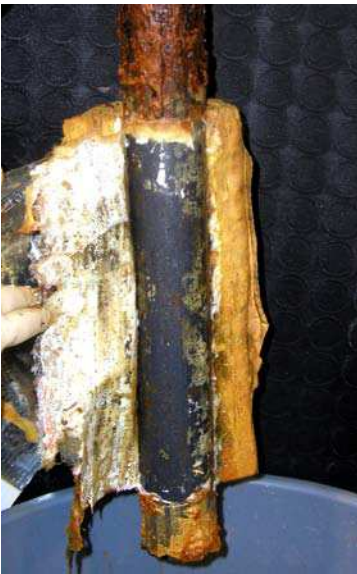
At 365 Days

At 365 days, this sample was removed. Inspection showed no corrosion on the treated area.

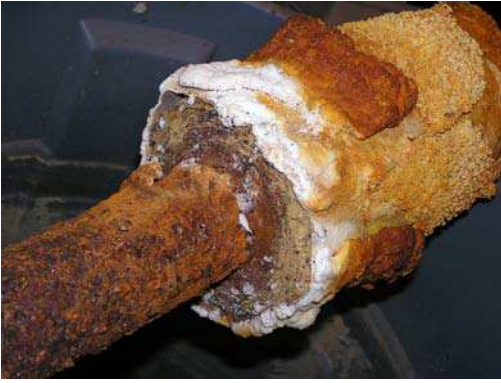
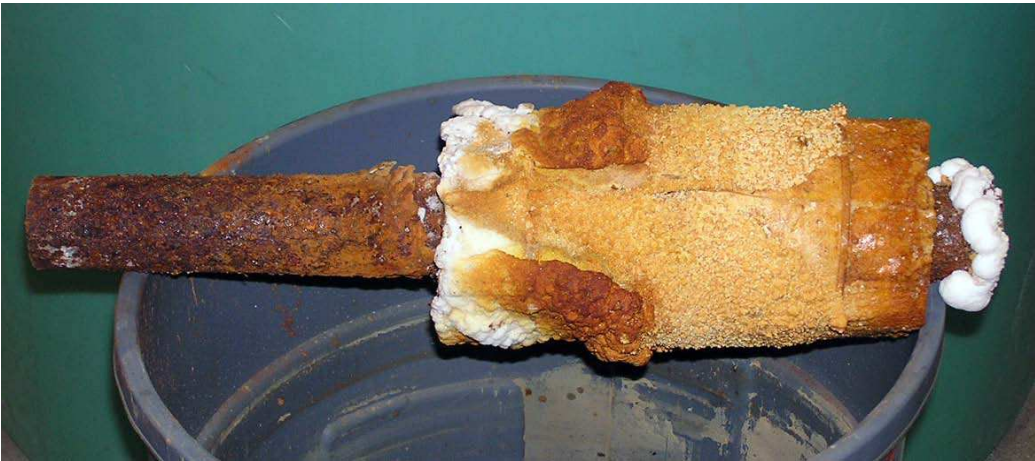
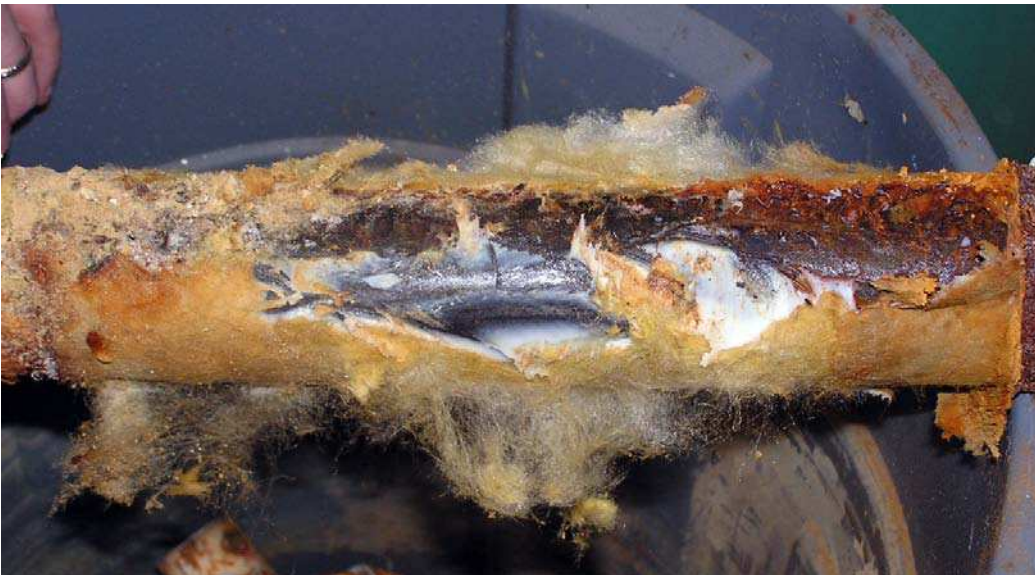
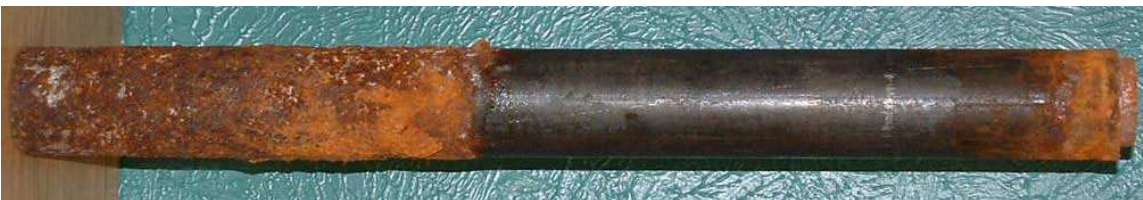
At Two Years

After two years, the insulation had begun to rot, but there was almost no corrosion on the treated area under the insulation.
